CITY OF MENDOTA

SAFE ROUTES TO SCHOOL MASTER PLAN

SAFETY DATA ANALYSIS & RECOMMENDED IMPROVEMENTS

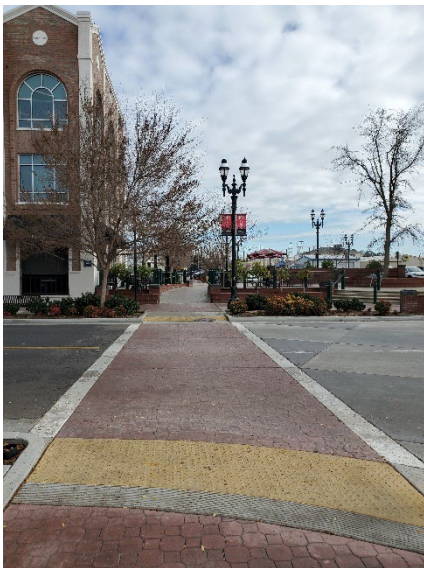
Alternative Materials

Changing the material of the crosswalk highlights the prevalence of pedestrians in the area.

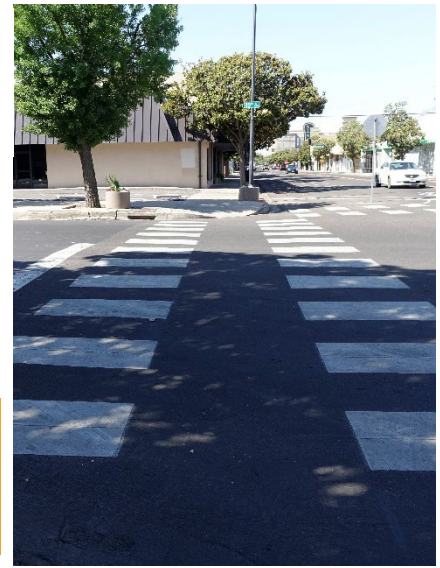
Alternative Striping

Alternative striping methods can be a less expensive way to highlight pedestrian activity in an area without changing the crosswalk material.

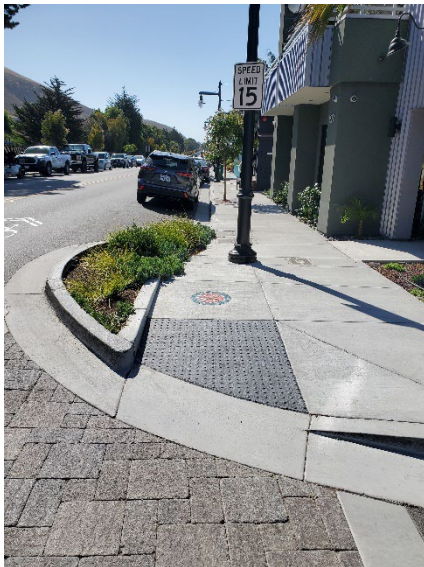
Bulb-outs extend the curb into the intersection, protecting pedestrians and making them more visible as they prepare to cross the street. They also narrow the visual lane and encourage slower travel speeds.

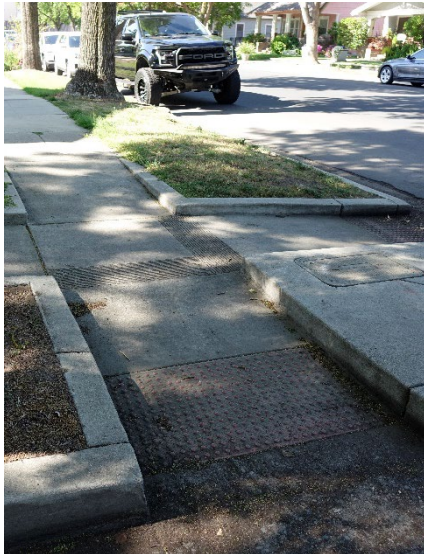
Directional Ramps

Directional ramps are preferred to protect pedestrians and separate them from moving traffic.

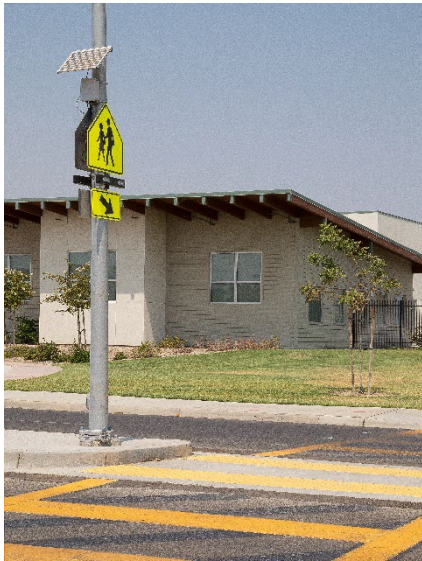
Flashing Beacon

Flashing beacons can be activated by pedestrians to alert drivers to people crossing the road.

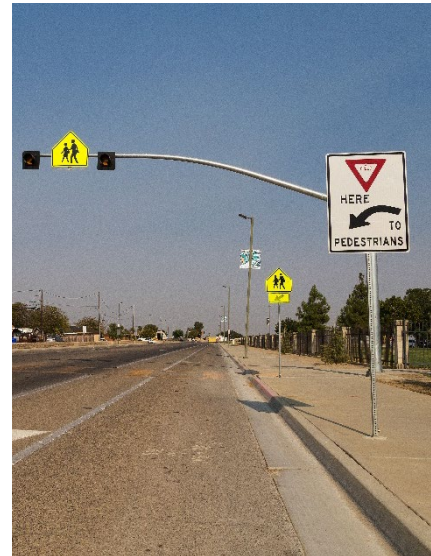
Sign Location

Signs should be located with a clear relationship to an intersection or crossing.
