MCCABE ELEMENTARY SCHOOL

MENDOTA ELEMENTARY SCHOOL

WASHINGTON ELEMENTARY SCHOOL

MENDOTA JUNIOR HIGH AND HIGH SCHOOLS

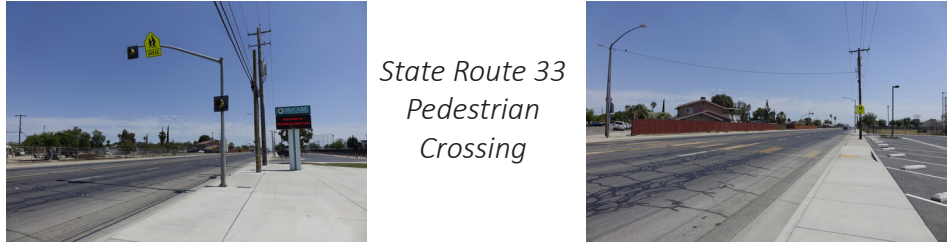
3 FLASHING BEACON CONCERNS

The midblock crossing on State Route 33 has a flashing beacon associated with it. However, the lights are located a significant distance from the actual crossing and flash constantly, which makes it difficult for drivers to associate the lights with a pedestrian crossing the street.

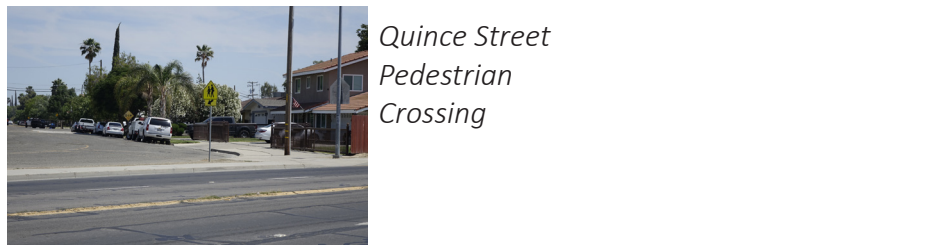
4 CONFUSING SIGNAGE

Pedestrian crossing signage near the State Route 33 midblock crossing and Quince Street crossing creates confusion about where pedestrian activity is likely.

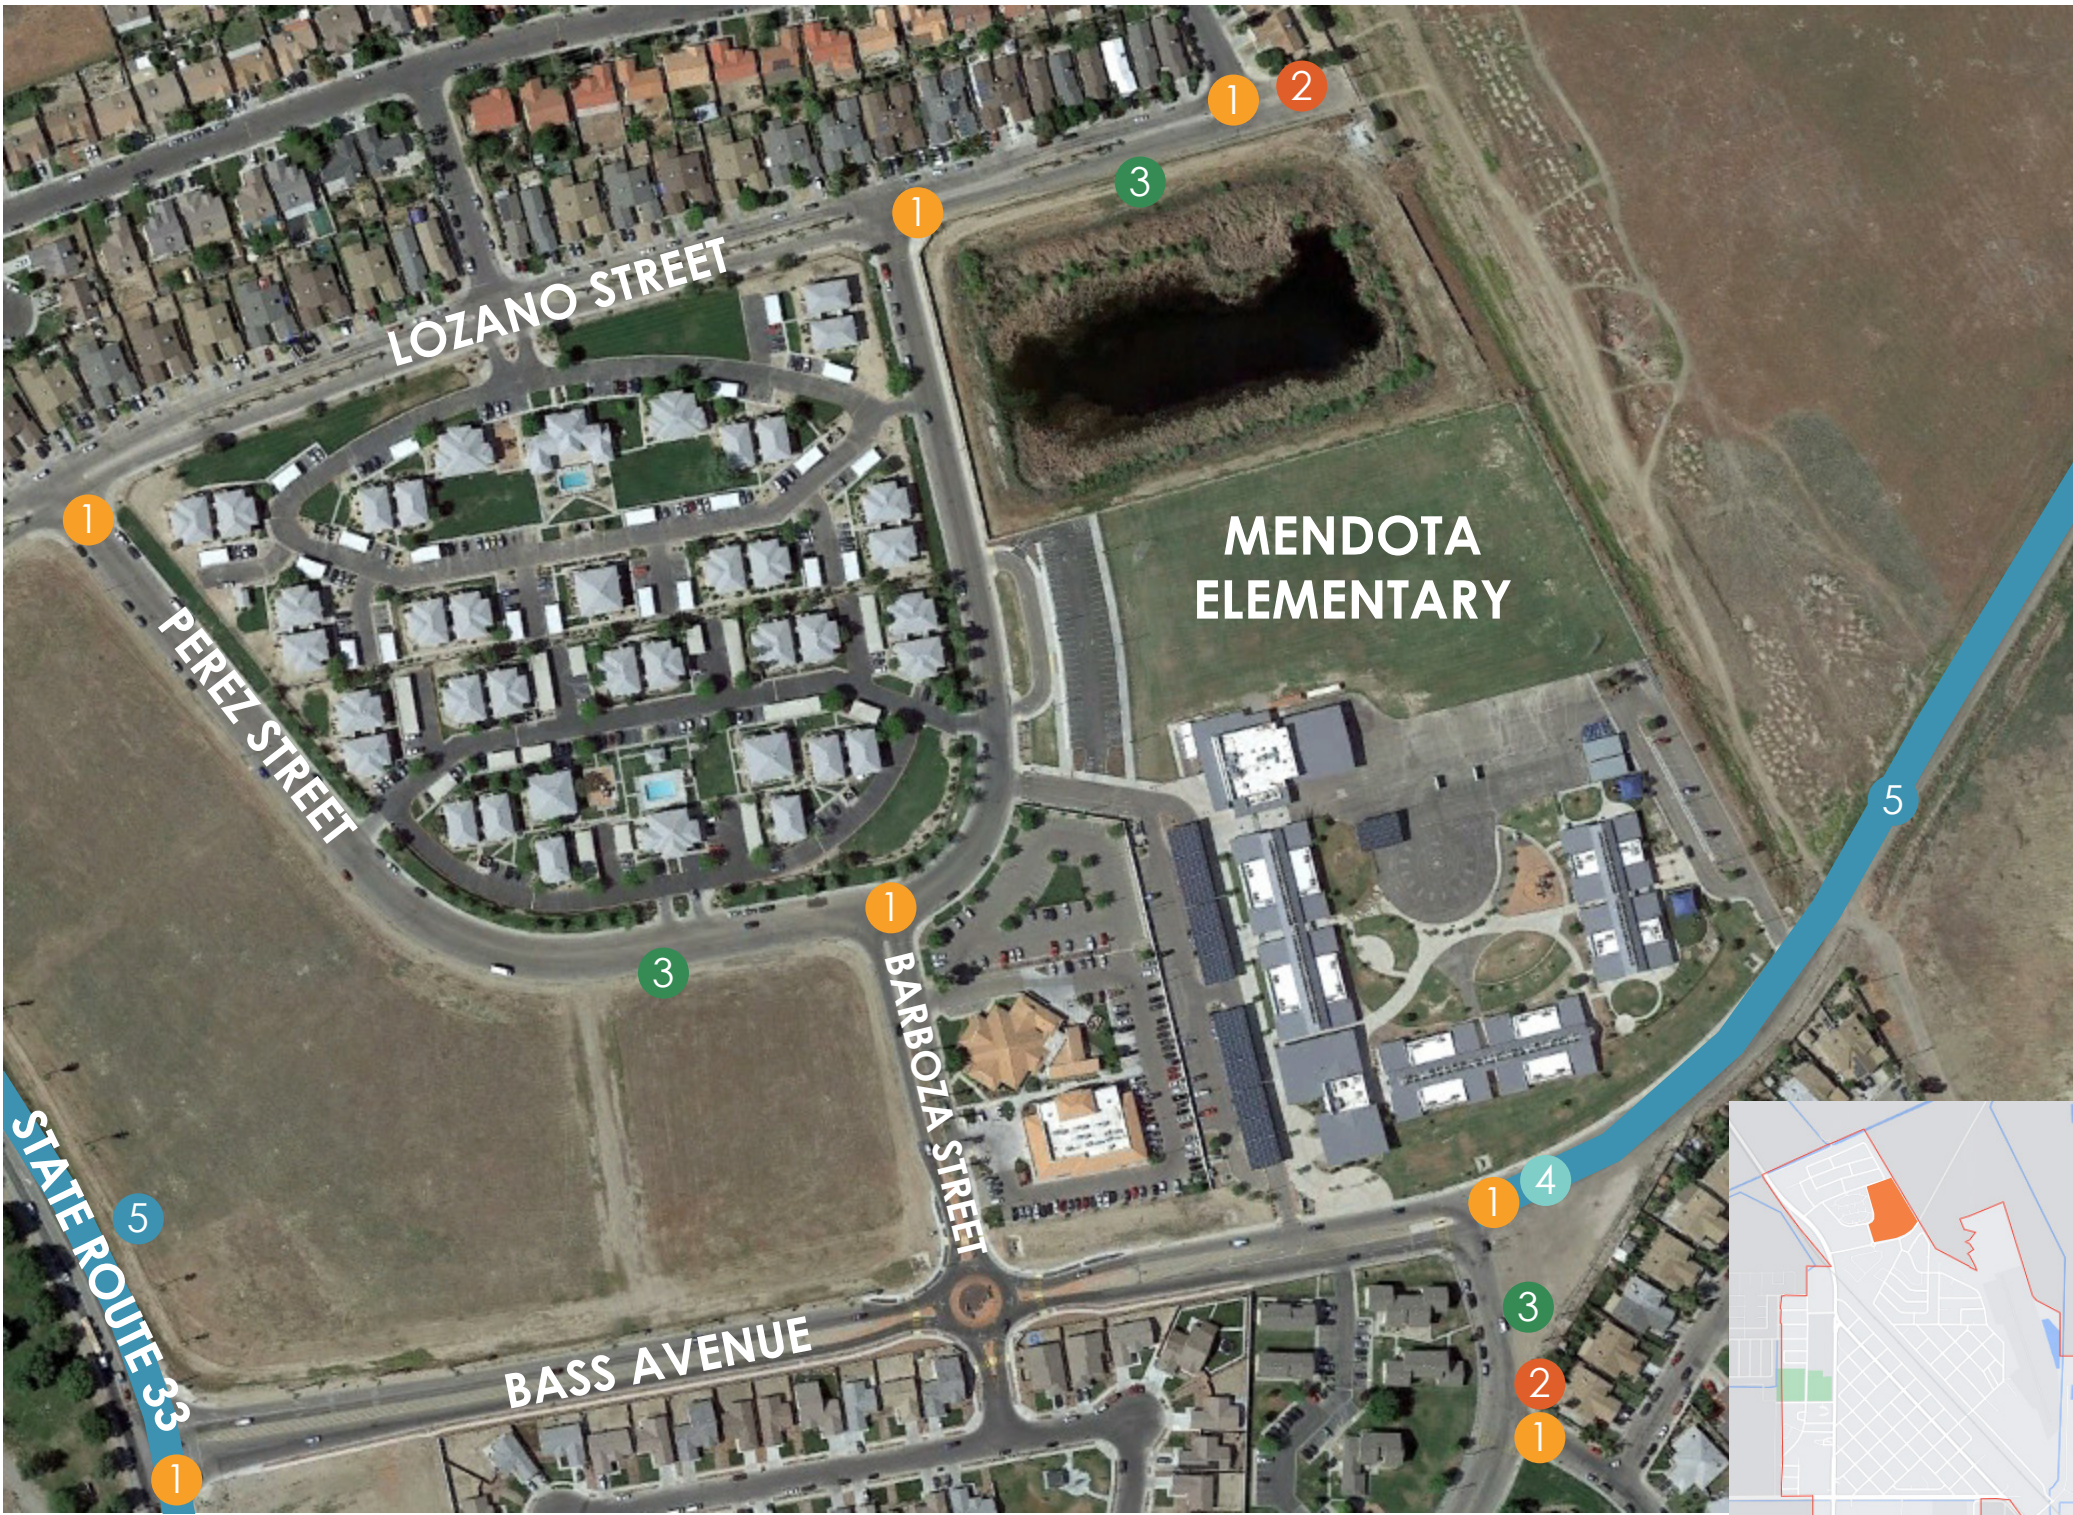
5 HIGH SPEED CORRIDOR

Street design contributes to frequent speeding along Derrick Avenue (State Route 33) and Bass Avenue. A road diet was completed on SR 33 which is anticipated to address speeding concerns.

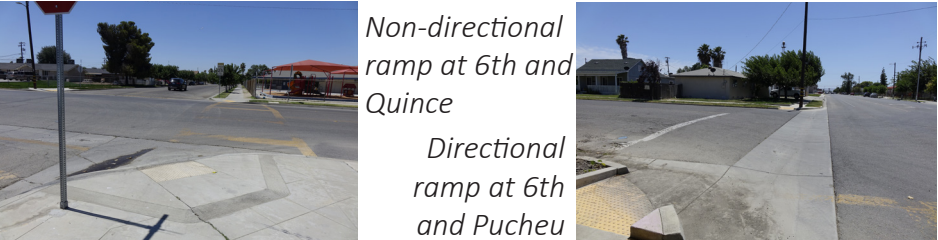
2 NON-DIRECTIONAL PEDESTRIAN RAMPS
Pedestrian ramps may either point into the center of the road (non-directional) or towards the specific direction of the crossing (directional). Non-directional ramps direct pedestrians into the intersection with cross-traffic, so directional ramps are preferred.

Non-directional ramp at 6th and Quince

Directional ramp at 6th and Pucheu

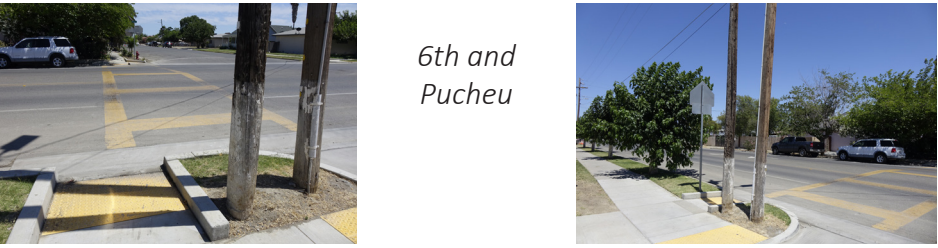
3 MISALIGNED CROSSWALK
The crosswalk at 6th and Pucheu streets is not aligned with the pedestrian ramp.

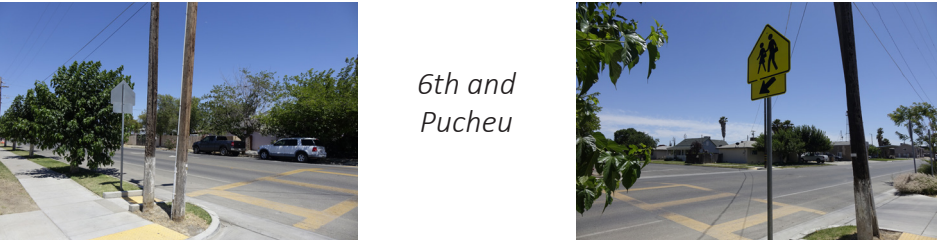
6th and Pucheu

4 BLOCKED SIGNAGE
Trees block pedestrian crossing signage from view from the street.

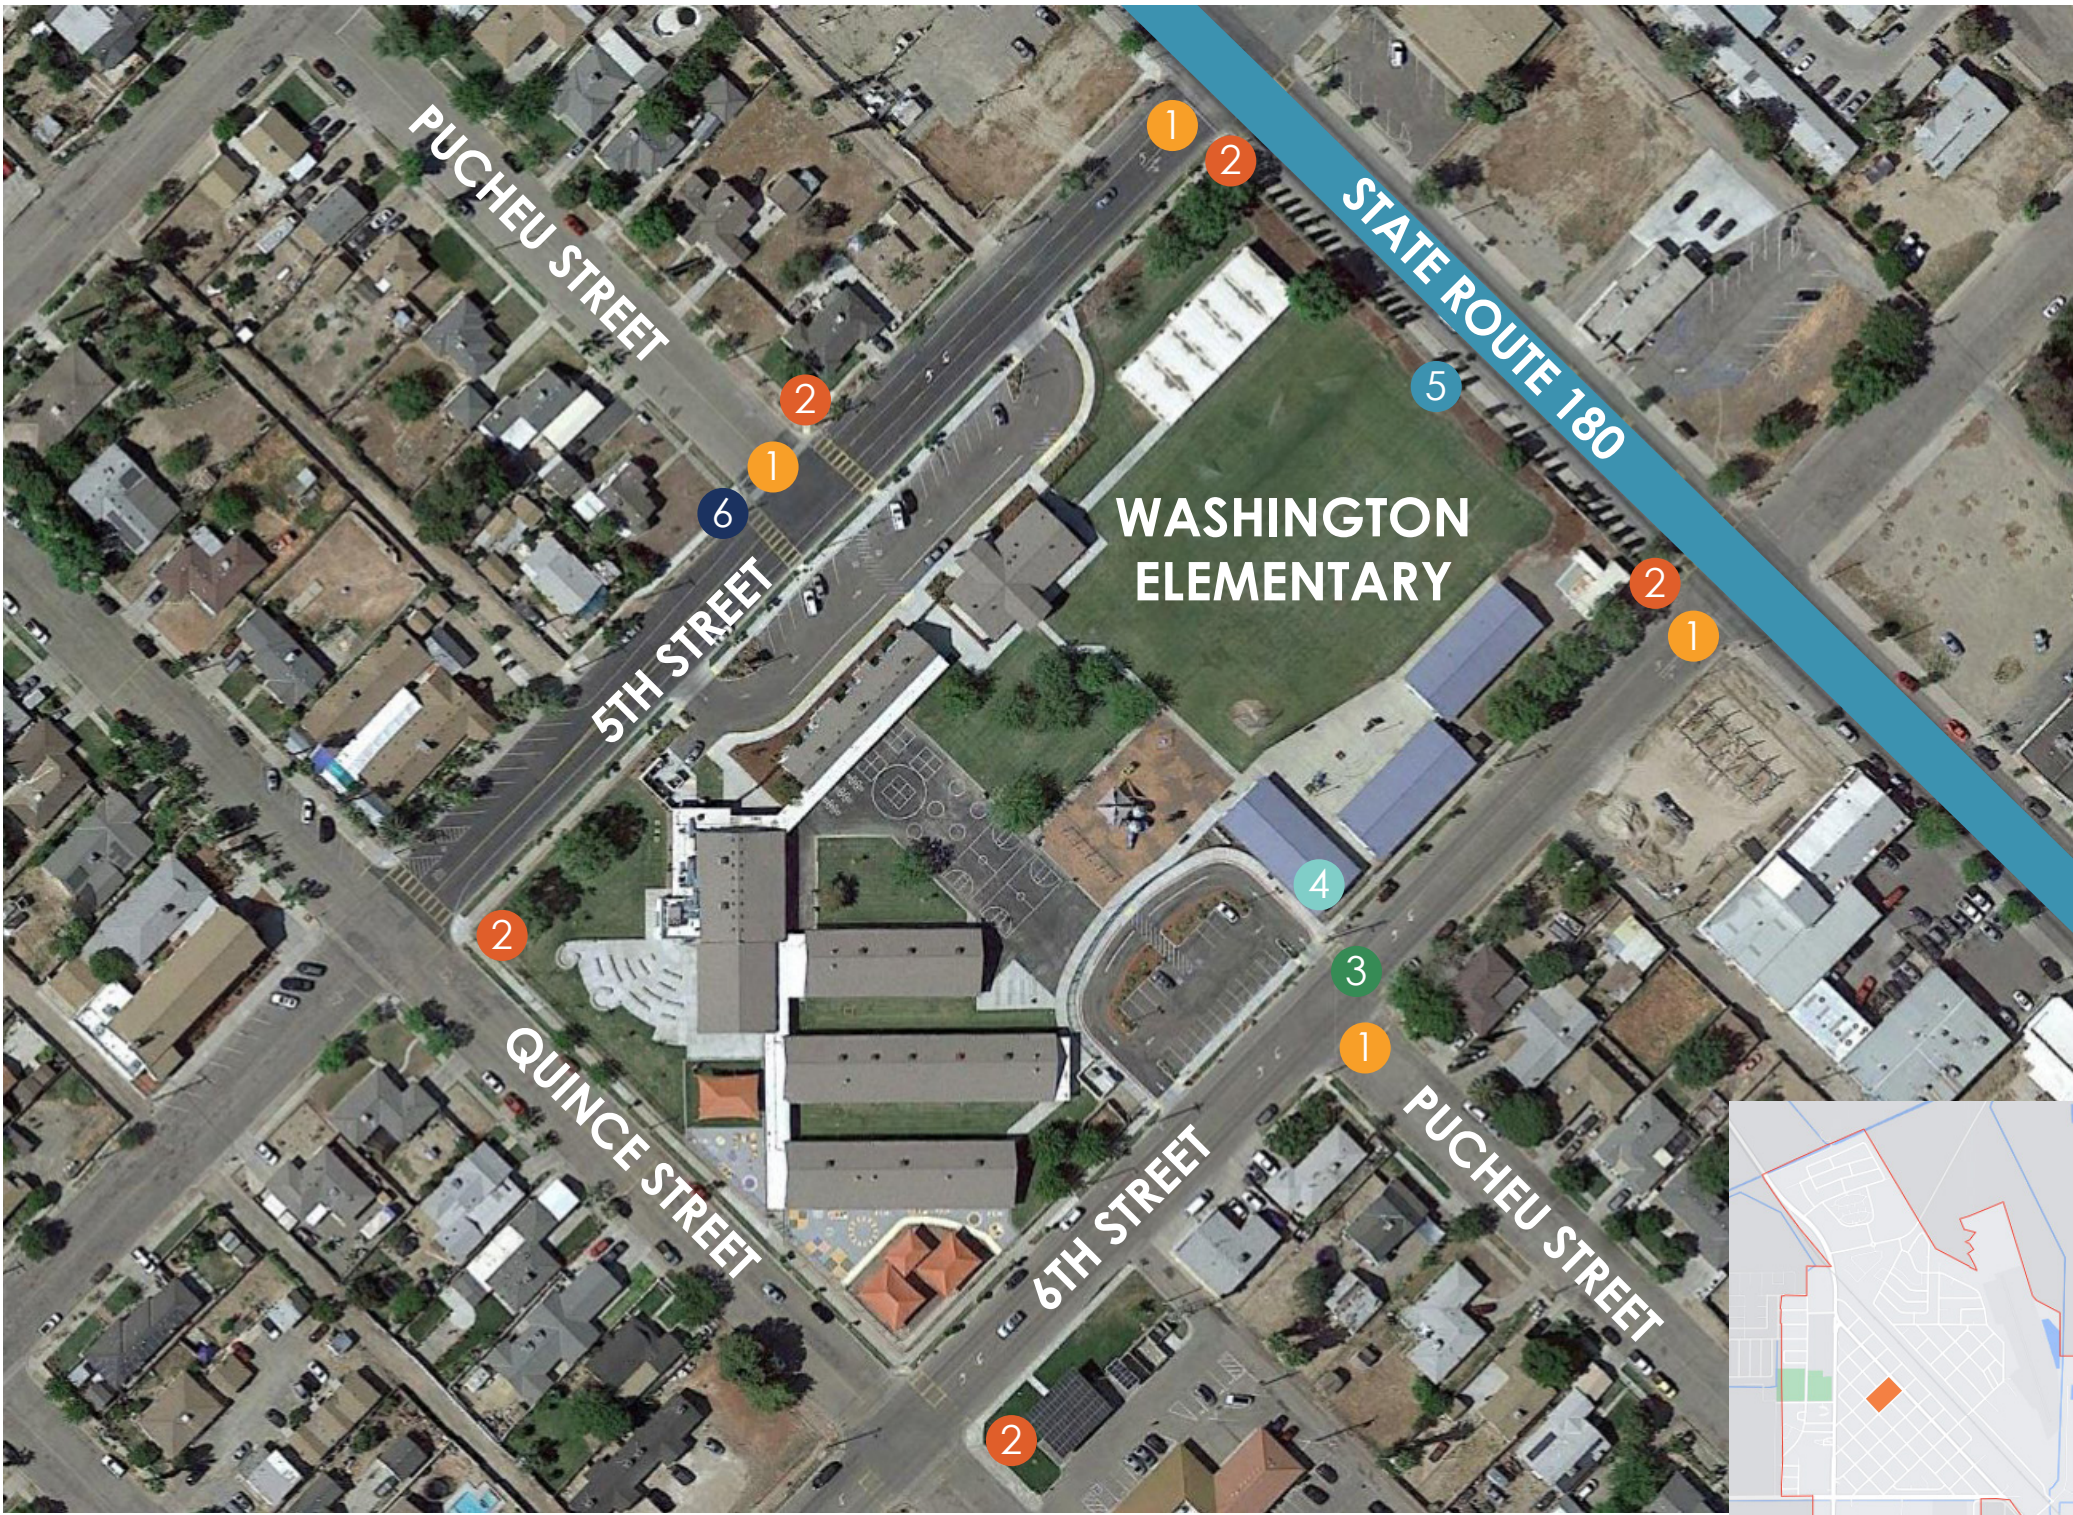
5 HIGH SPEED CORRIDOR
Street design contributes to frequent speeding along Oller Street (State Route 180). A road diet was completed in mid-2022 which reduced the streets to one travel lane in each direction with a bike lane and parking lane where appropriate. Marked crossings were also added as part of this project. The road diet is anticipated to address speeding concerns.

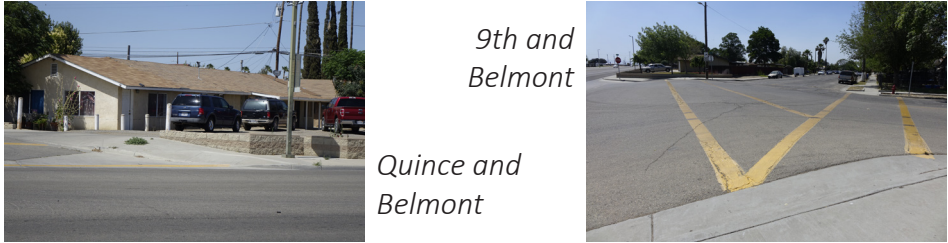
3 CONFUSING INTERSECTIONS

Three-street intersections cause confusion and conflicts between vehicles and pedestrians regarding who should move when. Some ramps do not line up with crosswalks. A project is currently underway to add an overhead beacon at 9th Street and Belmont Avenue, which may help address these concerns, though some additional improvements may be necessary.

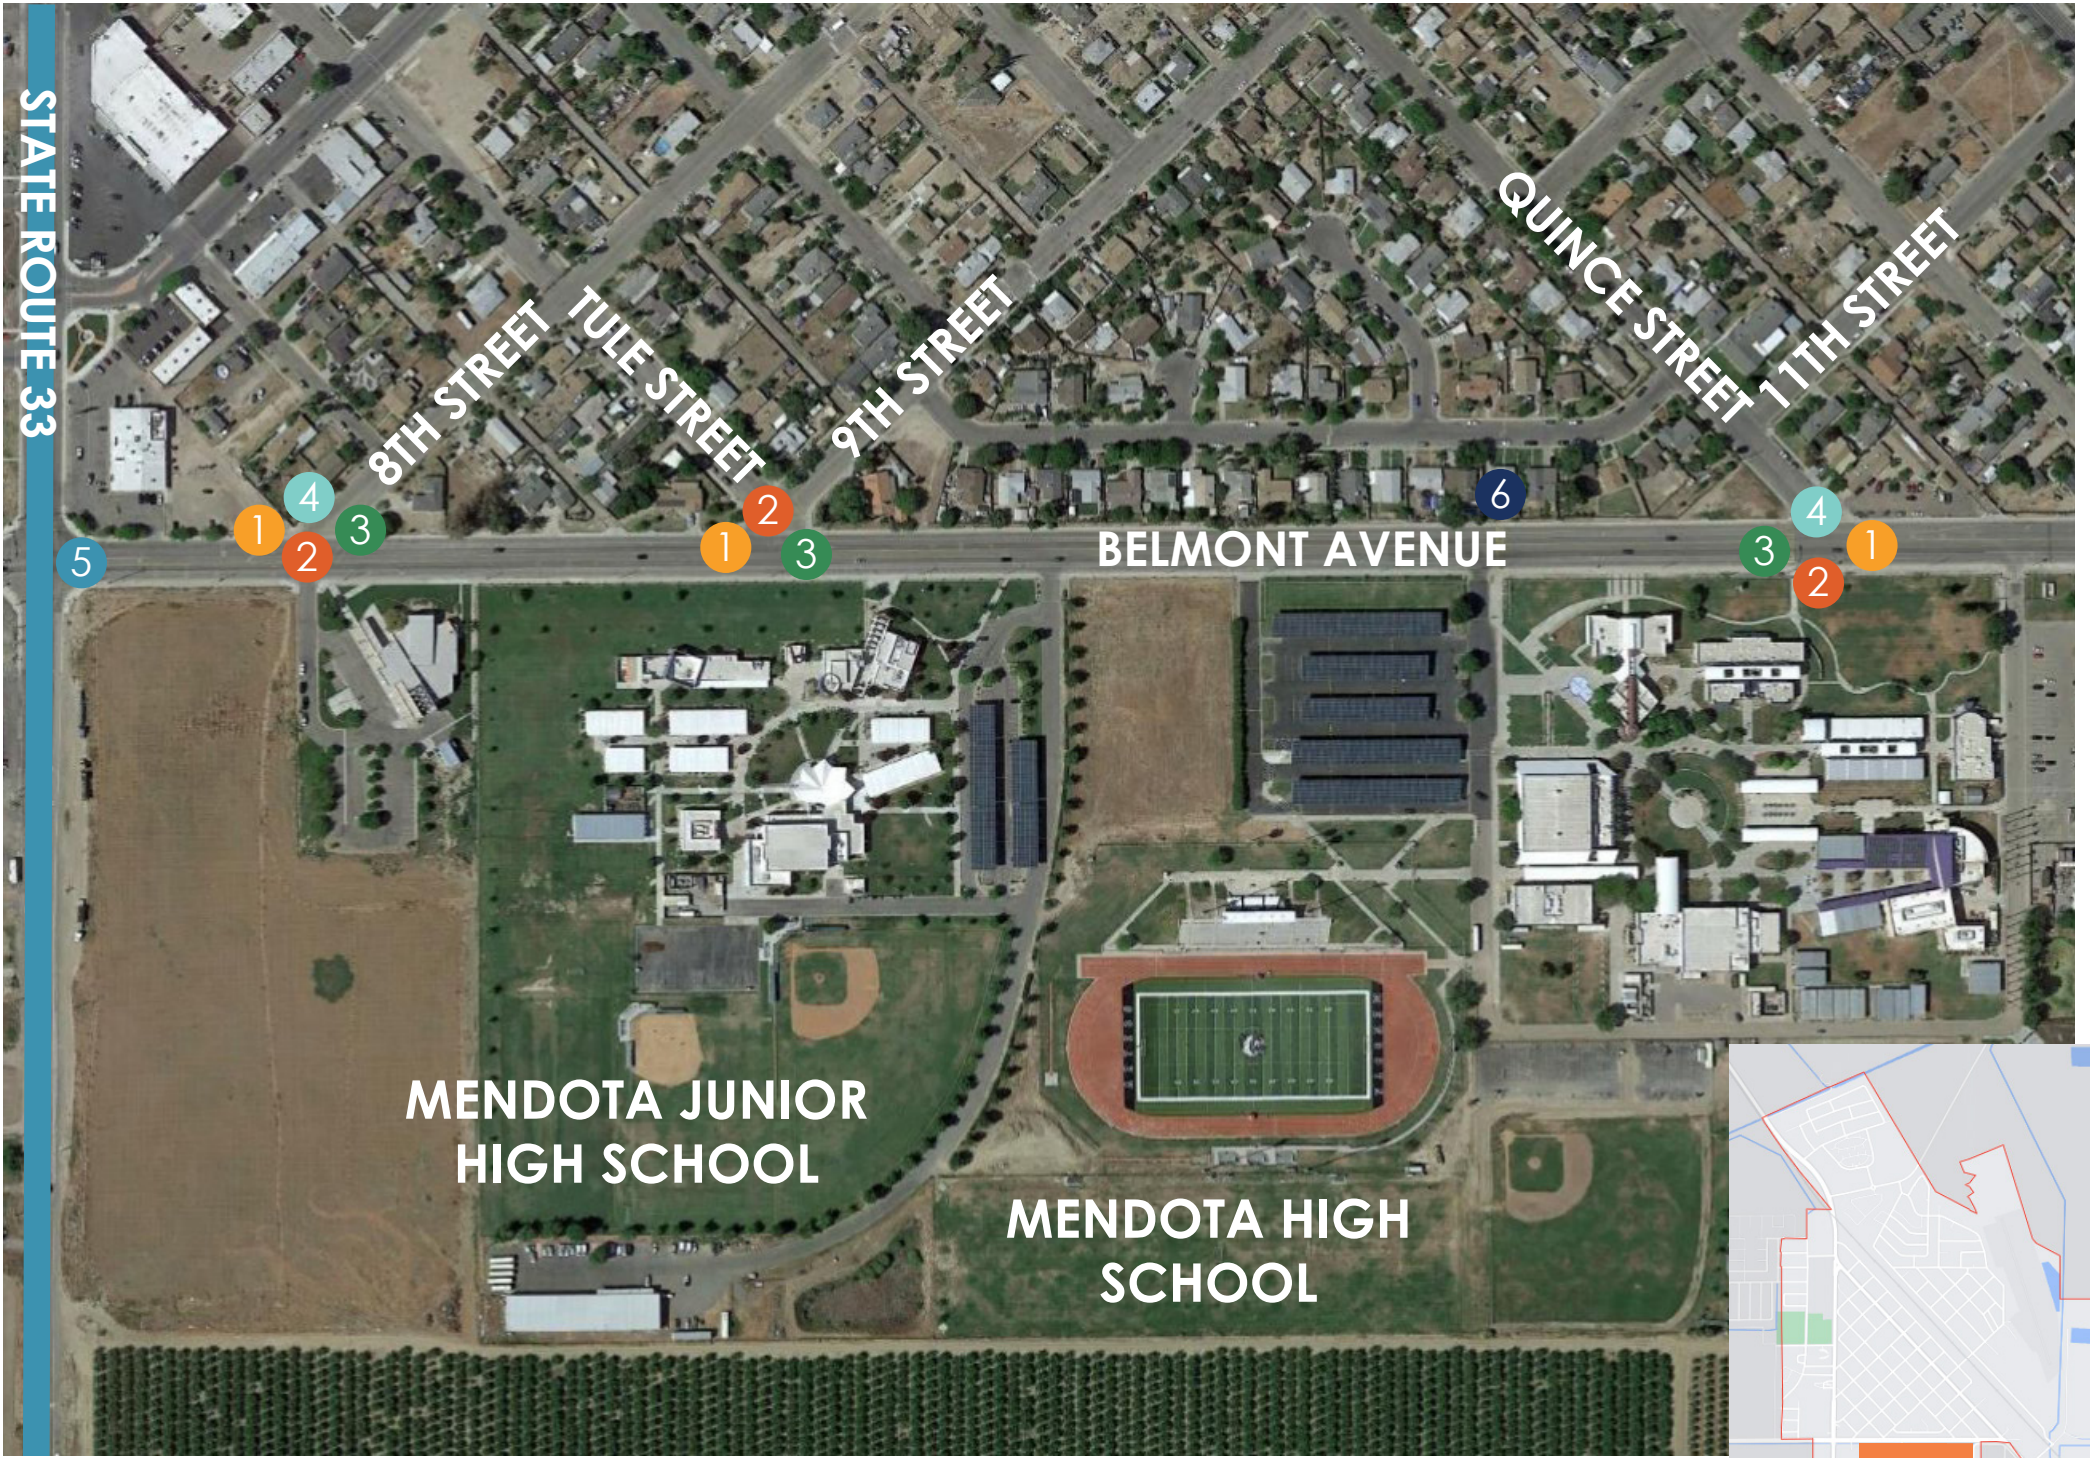
5 HIGH SPEED CORRIDOR

Street design contributes to frequent speeding along Derrick Avenue (State Route 33). A road diet has been completed which reduced the number and width of travel lanes. Additional pedestrian infrastructure is also planned along the corridor which may also address speeding concerns.

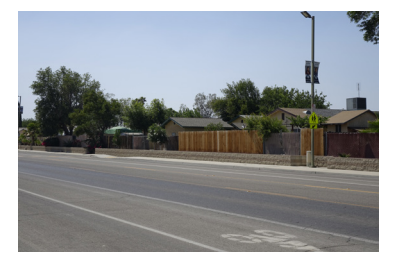
6 CONFUSING SIGNAGE

Pedestrian crossing signage is not clearly related to the actual crosswalk.
